Final Commissioning Report For Woodland High School

July 2017

Appendix A – Field Reports, Testing & Issues Log

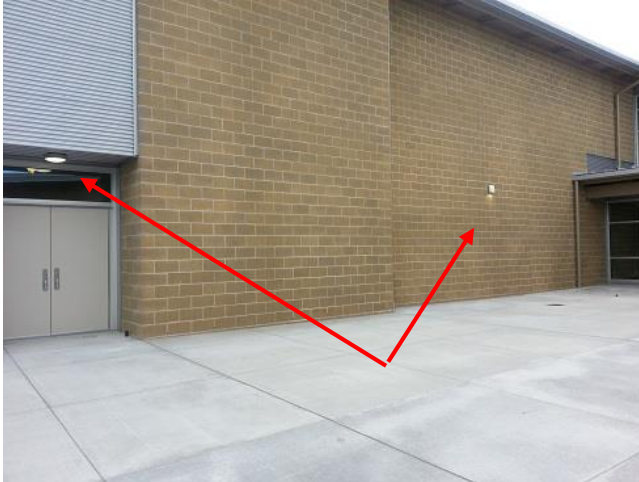
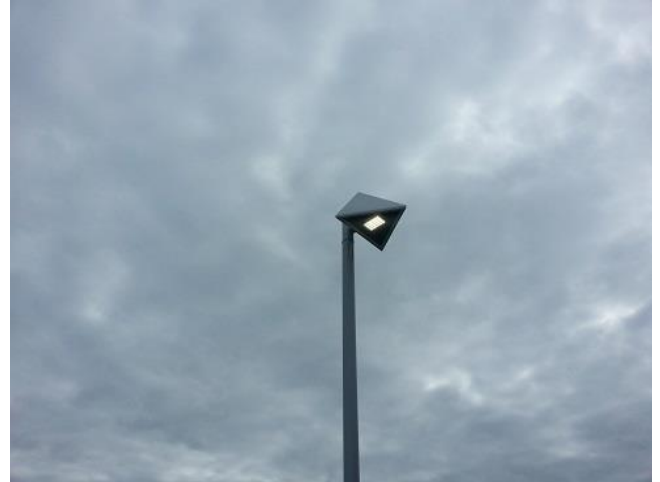
ID	Summary	Proposed Resolution	Actual Resolution	Date resolved
E-01	Exterior lights are on during daylight hours. As of 07.20.15 --CSG noted all exterior lighting around the main school building and the parking lots remained off. 06.09.15 --While on site, CSG has noted all light fixtures attached to the perimeter of the building are remaining on all day. We have also noted where a few pole lights remained on during daylight hours as well, although they seemed to be off the last two days we were on site, 06.12.15. The Cooper Controls programmer on site stated the photo cell had been properly adjusted but this does not appear to be the case.	Advanced Electrical and perhaps the LV lighting manufacturer needs to determine the correct photocell settings so that lights are cycled on and off at the appropriate light levels. During training we asked the programmer whether this had been executed properly and to provide a copy of the settings for future reference. Could there be an issue with the relays or controllers?	08.27.15 --CSG verified over the course of several visits that exterior lighting was cycling on and off at appropriate ambient light levels. This suggests the lighting system is functioning in automatic mode. 06.22.15 --Bob with Advanced Electrical stated the lighting control panels had been left in an overridden state for testing purposes. They were trying to isolate a bad fuse. They have since been set to Auto and are functioning correctly.	08.27.15

Issue ID #E-01— Exterior lighting is on during daylight hours. Photocell may not be set up correctly.

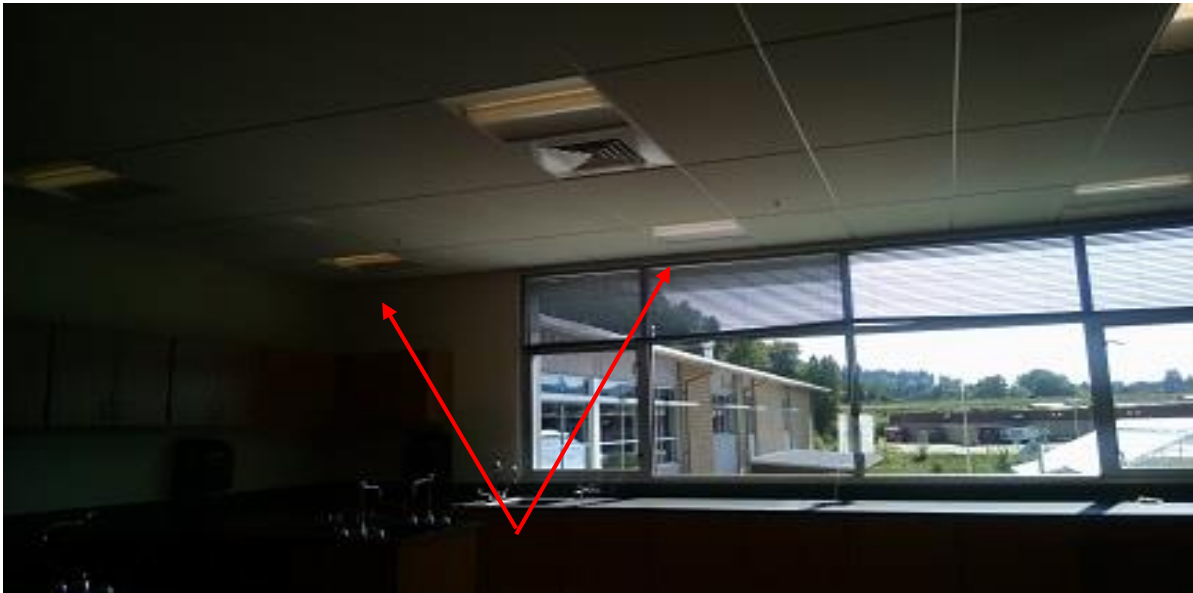
ID	Summary	Proposed Resolution	Actual Resolution	Date resolved
E-08	<p>06.09.15-- Classroom automatic daylighting harvesting controls are not working adequately. The installation of some lamps need to be reviewed by Advanced Electric. In some cases, we noted two pairs of fixtures are wired together and both fixtures dim according to the photocell receiving the most light. The two fixtures wired together may include a fixture located completely within a daylighting zone along with a fixture that is only adjacent to, or partially within a daylighting zone. This creates a less-brightly lit area at the fixture that does not receive direct sunlight. This requires a compromise between not dimming much at the window, or getting too dim away from the window. In other classrooms where the fixtures are separately dimmed, each fixture can be adjusted with its rotating photocell shield to dim more appropriately. Having noticeably different light levels may be a nuisance.</p>	<p>CSG worked with Advanced Electrical to find a compromise in dimming functions between the two fixtures but the end result will be that the light completely within the daylighting zone will never dim as much as it could if it were being singularly controlled by its own photocell. BCE may need to review the lighting operations along with the district to determine whether the present installation is adequate. All areas within the classroom must meet the WAC requirements for foot candles which they don't presently do.</p>	<p>06.25.15--Bob with Advanced Electrical stated diodes were added to individual lights to prevent dimming in adjacent fixtures that did not have the required foot candles. This appears to have provided more light level consistency in the daylighting zones. CSG has re-tested and verified the daylighting controls functioned per design. The areas where lamps were not directly in front of a window proved to remain above the WAC minimum requirements for light levels in classrooms.</p> <p>06.17.15- Bob called this AM to inform us the Cooper Lighting Regional Rep will be on site today at 10:30 to discuss the lighting issues and mentioned they may have a fix that they will try on one classroom and if it works, it will be applied to all rooms that are affected by the issue.</p>	07.25.15

Issue ID #E-08—Dimming fixtures sharing a common light sensor, dimming light below WAC minimum requirements in areas of the space with no windows.

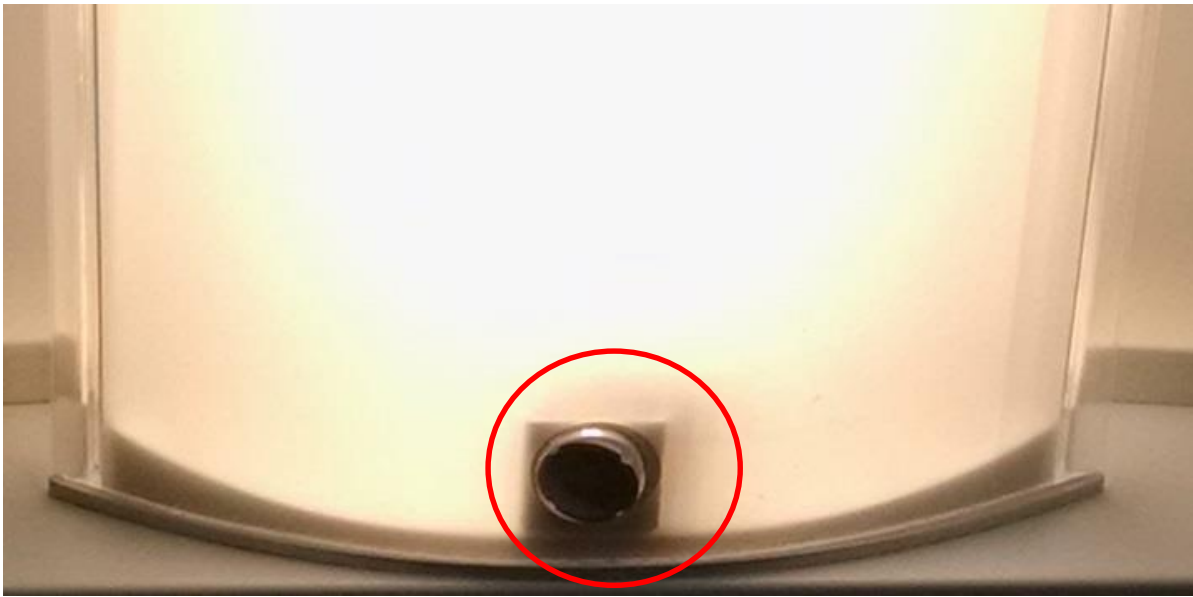
Issue ID #E-10—the photocell cannot sit flush in any fixture thereby causing it to be angled towards or away from daylight. It also allows the fixture light to affect the sensor

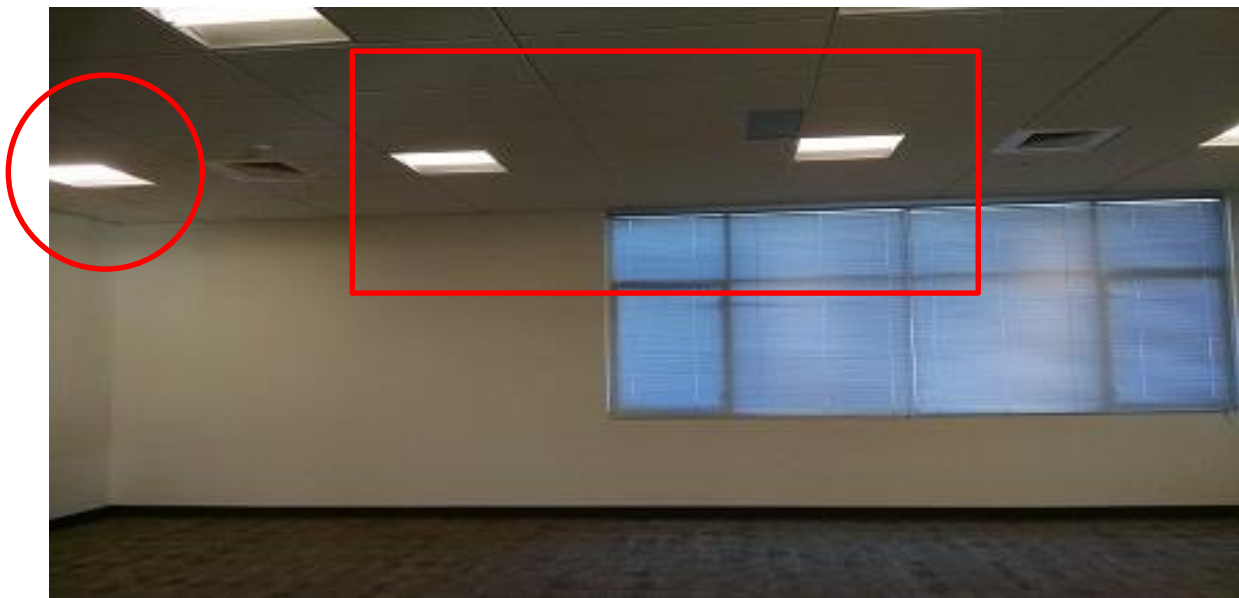
ID	Summary	Proposed Resolution	Actual Resolution	Date resolved
E-11	<p>06.09.15-- Light levels and daylighting in classrooms and labs are not working adequately. The photocells on the daylighting fixtures are being influenced by feedback of light from the fixture itself, leaking into the photocell housing, in addition to any daylight, resulting in classroom light levels below the WAC minimum when there is no daylight available. Variations in how much light is leaking into photocell housings appears to be a major cause of differences in lighting levels from one classroom to another on the order of 10 foot-candles in daylight harvesting zones. This difference is primarily observed when the blinds are down, since this increases the influence of the leaking light vs. sunlight. A difference in light level of 10 fc (or even 5 fc) is very noticeable. Several of the handful of rooms measured so far have light levels below the WAC minimum of 30 fc for classrooms. Light is leaked from the fixture itself into two locations on the photocell housing. 1.) Light is transmitted through openings in the plastic housing of the photocell (this is evidenced by the fact that taping around the housing with black electrical tape results in less light feedback and higher light levels in the classrooms). 2.) Light is transmitted into the gap between the adjustment ring and the plastic housing (this is evidenced by the fact that taping around the gap between the ring and the housing, after taping the housing itself, results in even higher light levels in the classrooms). The result is that with the photocell eye shade at minimum opening and the window blinds closed, some classrooms reveal only 26 foot-candles (fc) of light in areas where desks could be located at a height of 30" above the floor. This is below the WAC requirement of 30 fc in classrooms at a height of 30".</p>	<p>Advanced Electrical taped over the bodies of the photocells in fixtures located in classrooms 2404 & 2405. After the body of the enclosure is taped over with black electrical tape, the fixtures are noticeably brighter, and after the gap between the adjustment ring and body is taped, the lights are even brighter. Typically, it was determined that taping both areas is necessary to achieve acceptable light levels ranging from 33 to 42 fc in the dimmest areas of the room in three classrooms tested, up from 26 to 37 fc at the same test locations before taping. The exact light level may be dependent on exactly where the tape is placed, the angle of the sensor in its bracket (see issue ID E-10) and the tolerances of the fixture. A.E. should engage the manufacturer as well as BCE to review the dimming operations of the present installation. Taping every photocell is not a permanent solution for the district as it will not last long term. It is our expectations that the daylighting functions of the installed lighting systems not only meets the WAC requirements but the components and their installation fulfills its life expectancy.</p>	<p>06.25.15-- Bob with Advanced Electrical stated after correctly positioning the photocells in the mounting brackets as stated in Commissioning issue ID# E-10, it has reduced the amount of light entering the housing of the photocells. When all photocell- controlled fixtures in a classroom are positioned correctly, light levels have increased to meet or exceed the WAC requirements. CSG verified daylighting operations in all classrooms was working per design. The dimming levels from one lamp to another appears to be more uniform than before.</p> <p>06.17.15- Bob with Advanced Electrical called this AM to inform us the Cooper Lighting Regional Rep will be on site today at 10:30 to discuss the lighting issues. CSG plans on being there as well.</p>	07.25.15

Issue ID #E-11—with the blinds closed, all lights should be at their full bright levels. Here one can see the fixtures with photocells (within the box) are more dimmed than the fixture with no photocell sensor (circled) even though the blinds are drawn, indicating another light source is affecting the photocell. We believe this to be the light from the fixture itself.

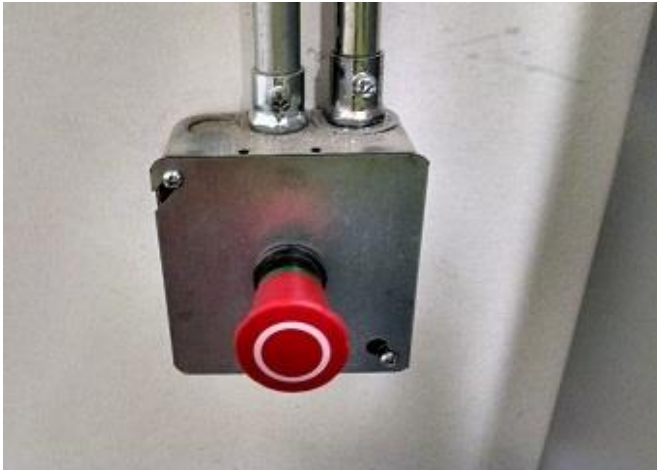
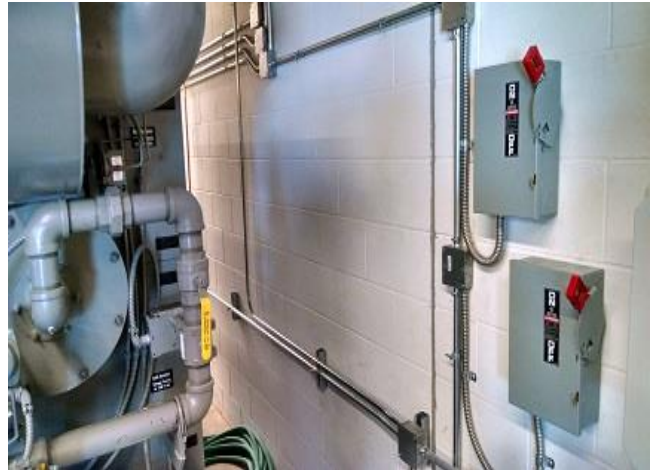
Issue ID #E-13—emergency pushbutton and disconnects located in the mechanical room require ID labeling.

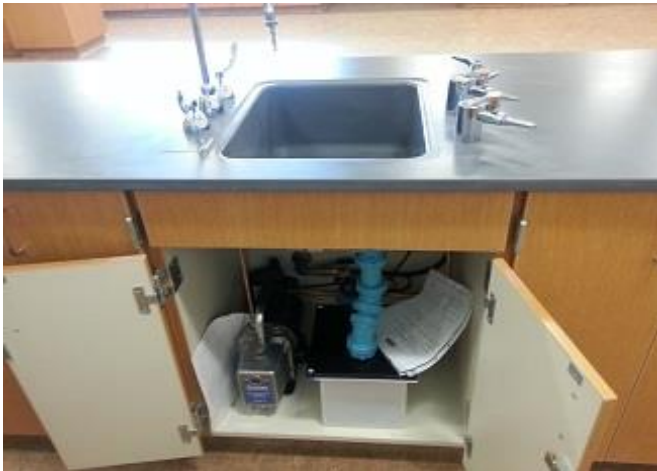
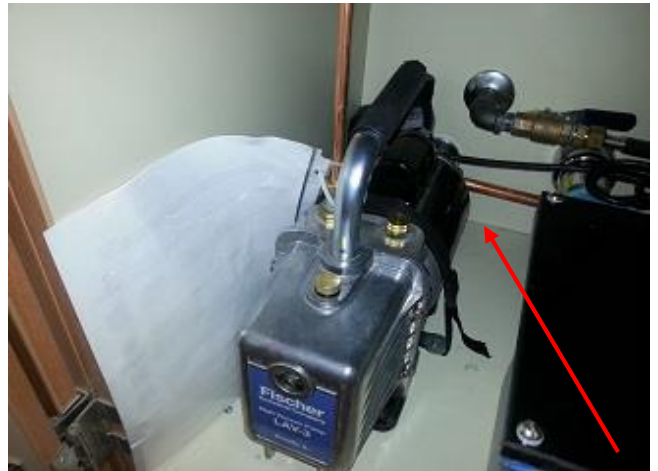
Issue ID #E-15—an end user switch has not been provided for the vacuum pump located in Chemistry lab 2401. A local switch integrated with the pump is located in the back, underside of the pump motor, but is not easily accessible.

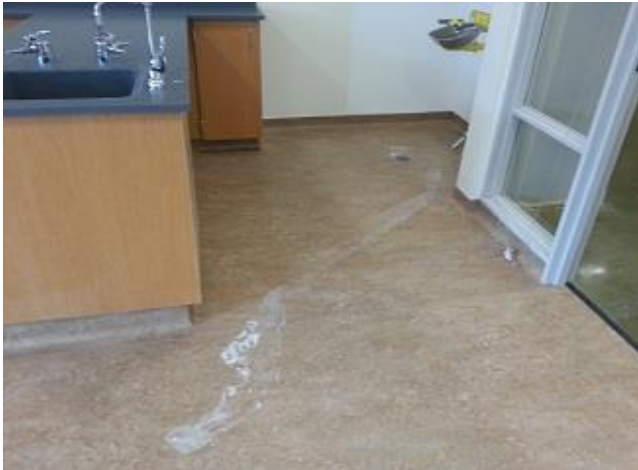
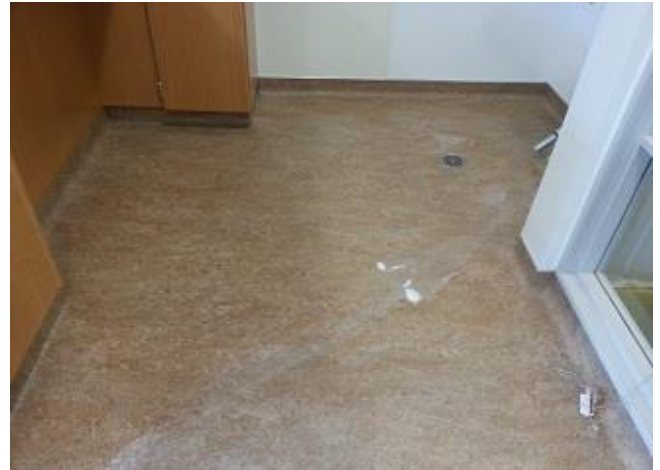
Issue ID #P-16—The drain is not adequately sloped to capture the flow of water from the the emergency wash station. On the right is residue from previous operations. On the right you can see a fresh stream of runoff bypassing the drain and pooling in front of the entry door.

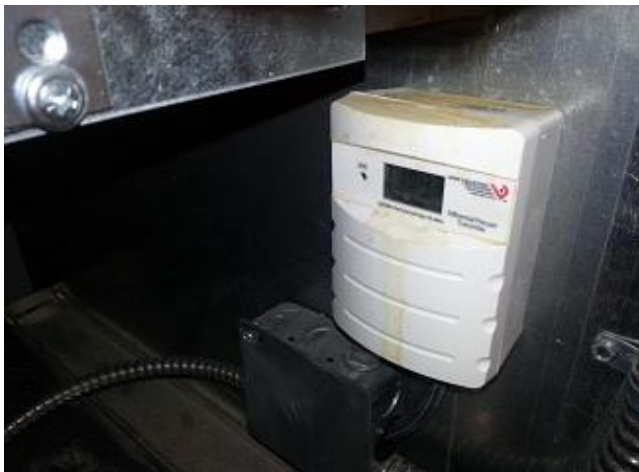
Issue ID #P-20—leak over Δp sensor

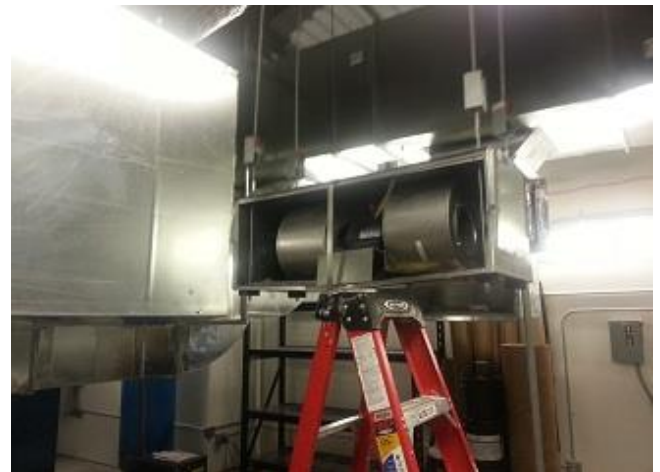
Issue ID #P-21- EF-8 is diassembled

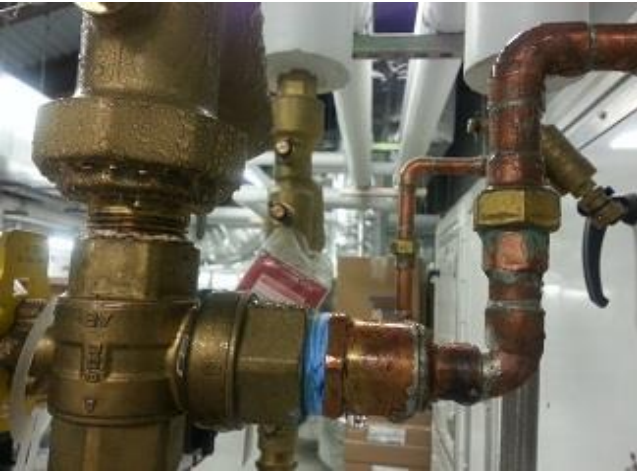
Issue ID #P-23—bypass piping insulation

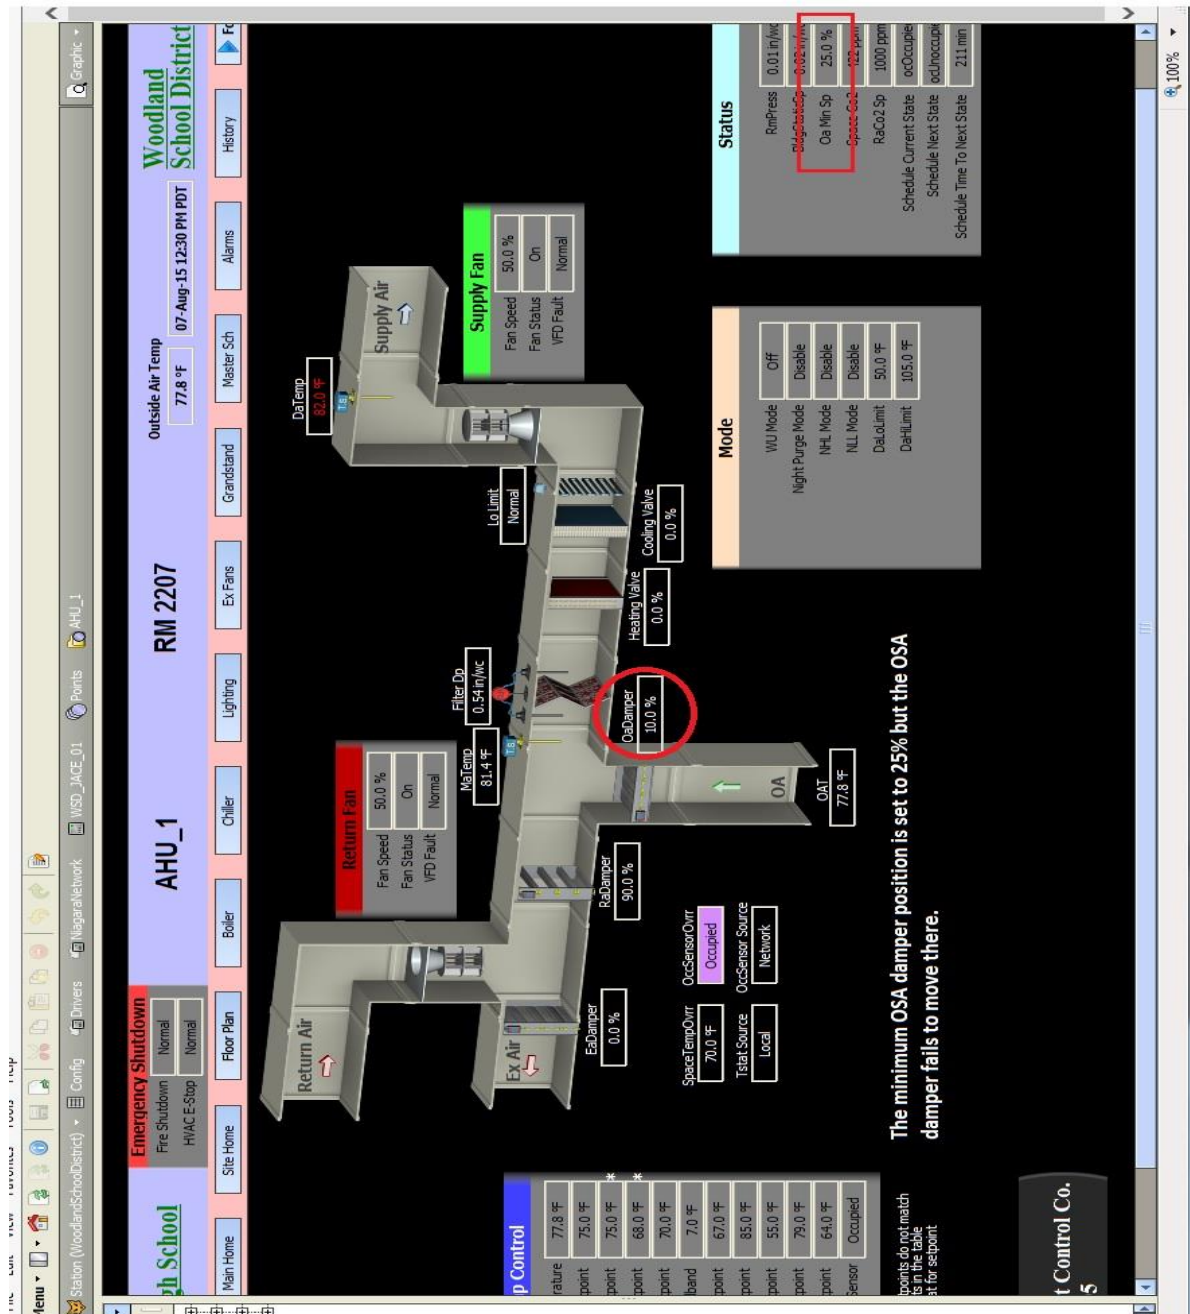
Issue ID M-31—AHU-1 moves to incorrect minimum damper position.

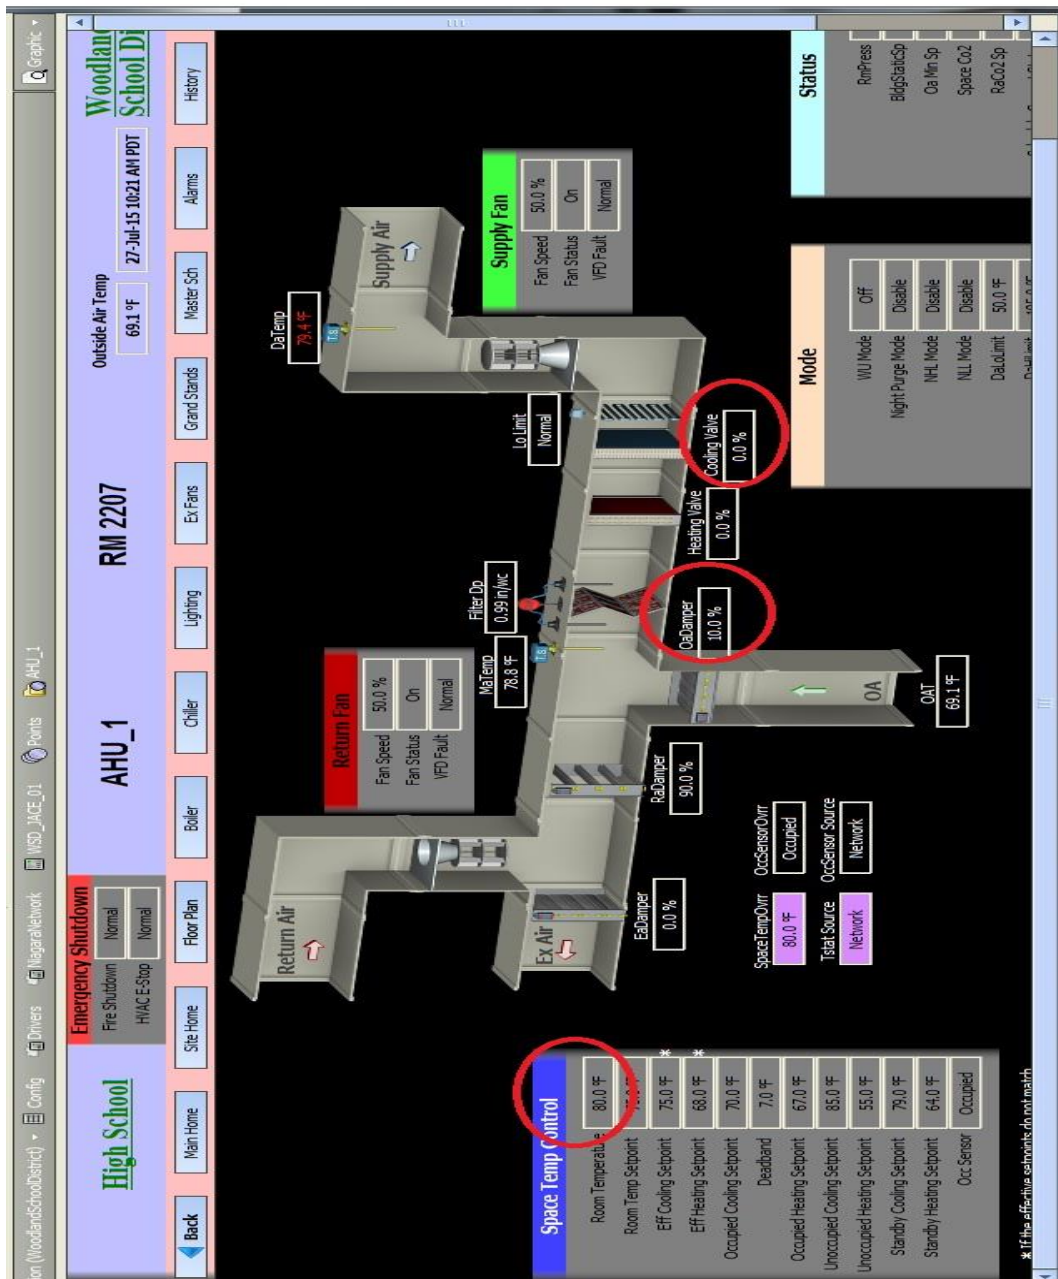
Issue ID M-32—AHU-1 did not include opening the cooling valve as part of it's cooling sequence of operations.

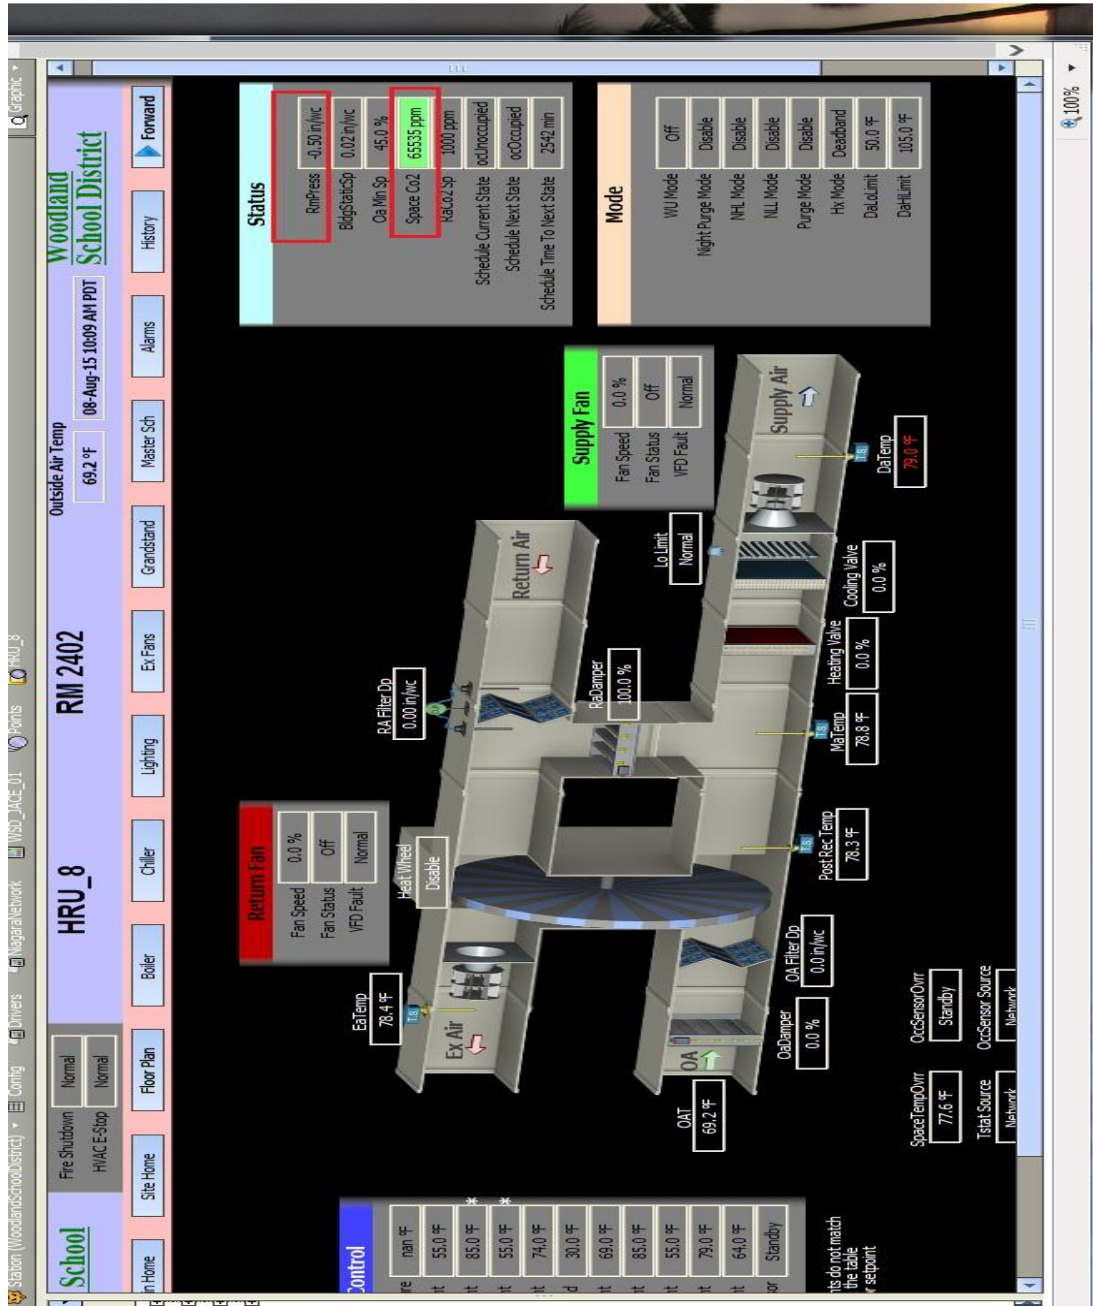
Issue M-33 and M-34—HRU-8 room static pressure reading is -.05" with all equipment off. The CO₂ reading is not being displayed accurately.

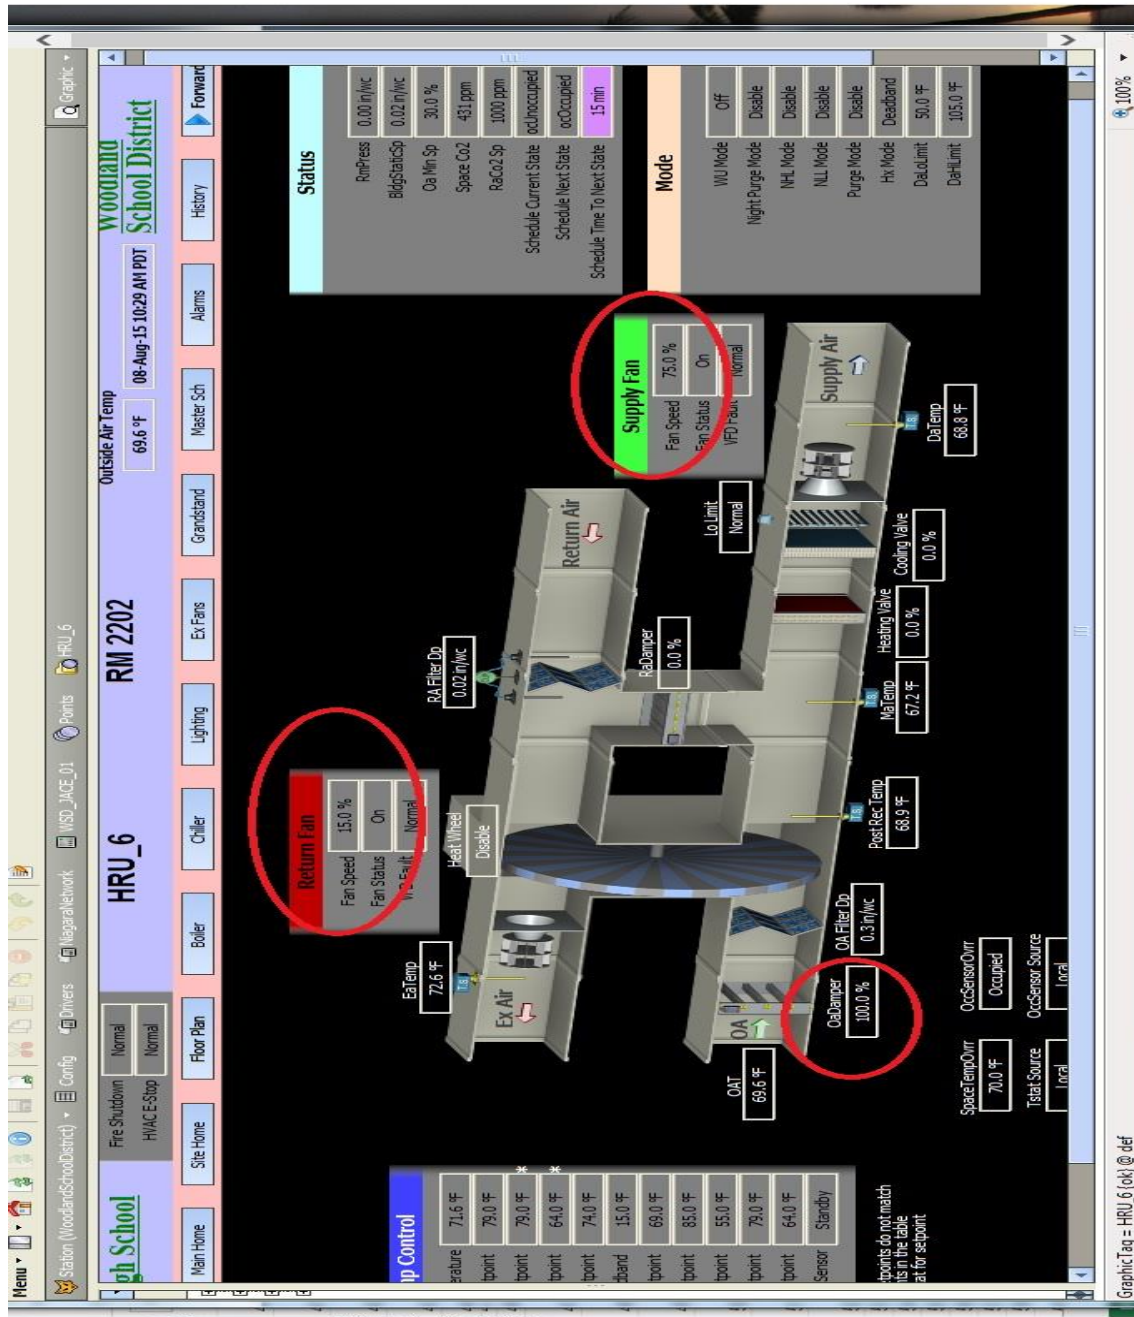
Issue ID M-36—HRU 6 was found running during unoccupied hours on a Sat morning. We notice an override is on regarding the next change of state.

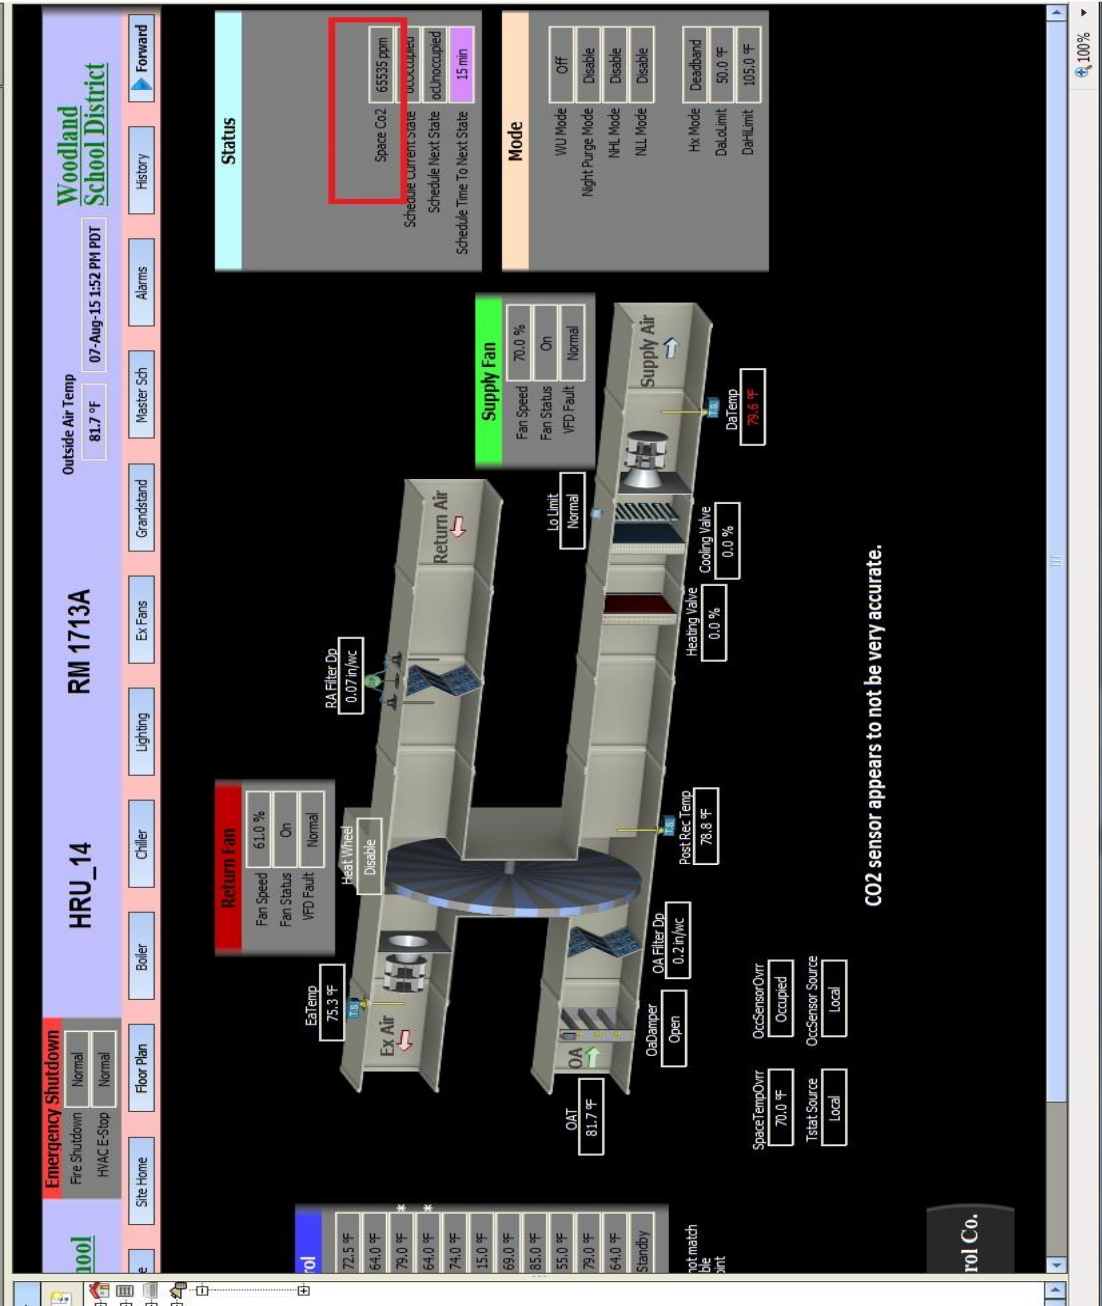
Issues ID M-37 & M-38—HRU-14 CO2 sensor is not being displayed accurately.

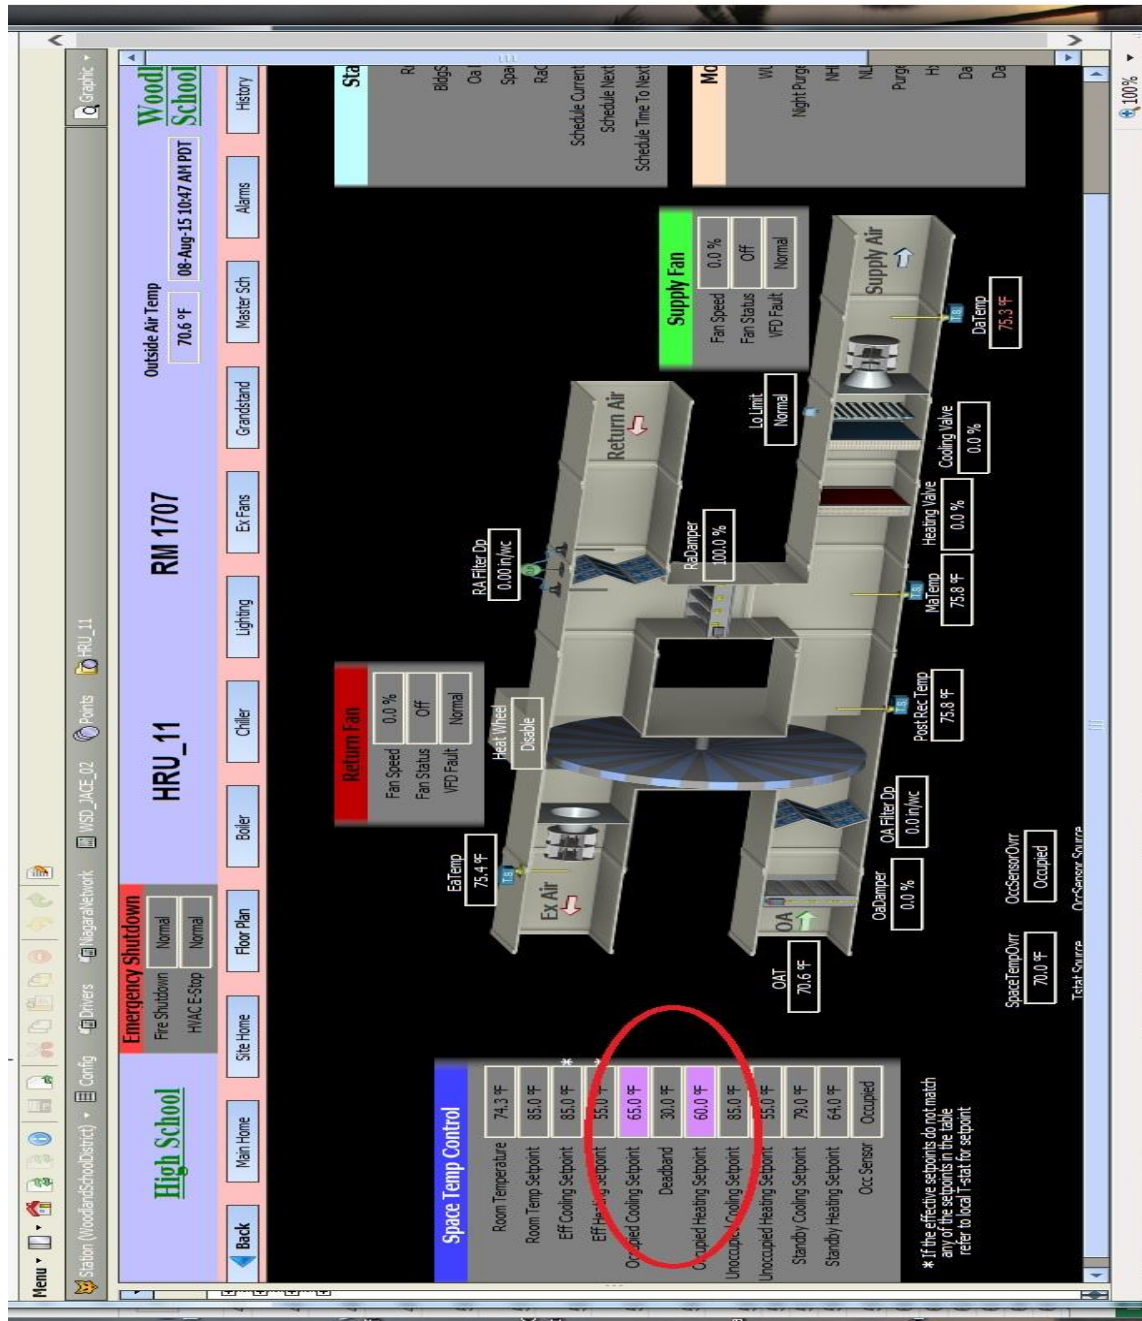
39	M-39	07.28.15	HRU-11 overridden	We discovered the cooling and heating set points overridden. Can NCC verify whether this is correct?	NCC	Closed
40	M-40	07.28.15	HRU-16 CO2 sensor	HRU-16 CO2 sensor display is not an accurate representation of CO2 levels.	NCC	Closed
41	M-41	08.08.15	AHU-22 Space pressure sensor	With the entire HVAC system in unoccupied mode and off, the space static pressure is reading a .01" which is not accurate.	NCC	Closed
42	M-42	08.08.15	ERU-1 sequence of operations	ERU-1 serving the Grandstands was found in occupied mode and running on Sat at 11:00 am when all HVAC equipment should remain off.	NCC	Closed
43	M-43	08.08.15	Chiller graphics	Although the chilled water system is off, the graphics reflect the condenser fans as running.	NCC	Closed

Issue M-39—HRU 11 heating and cooling set points have been overridden.

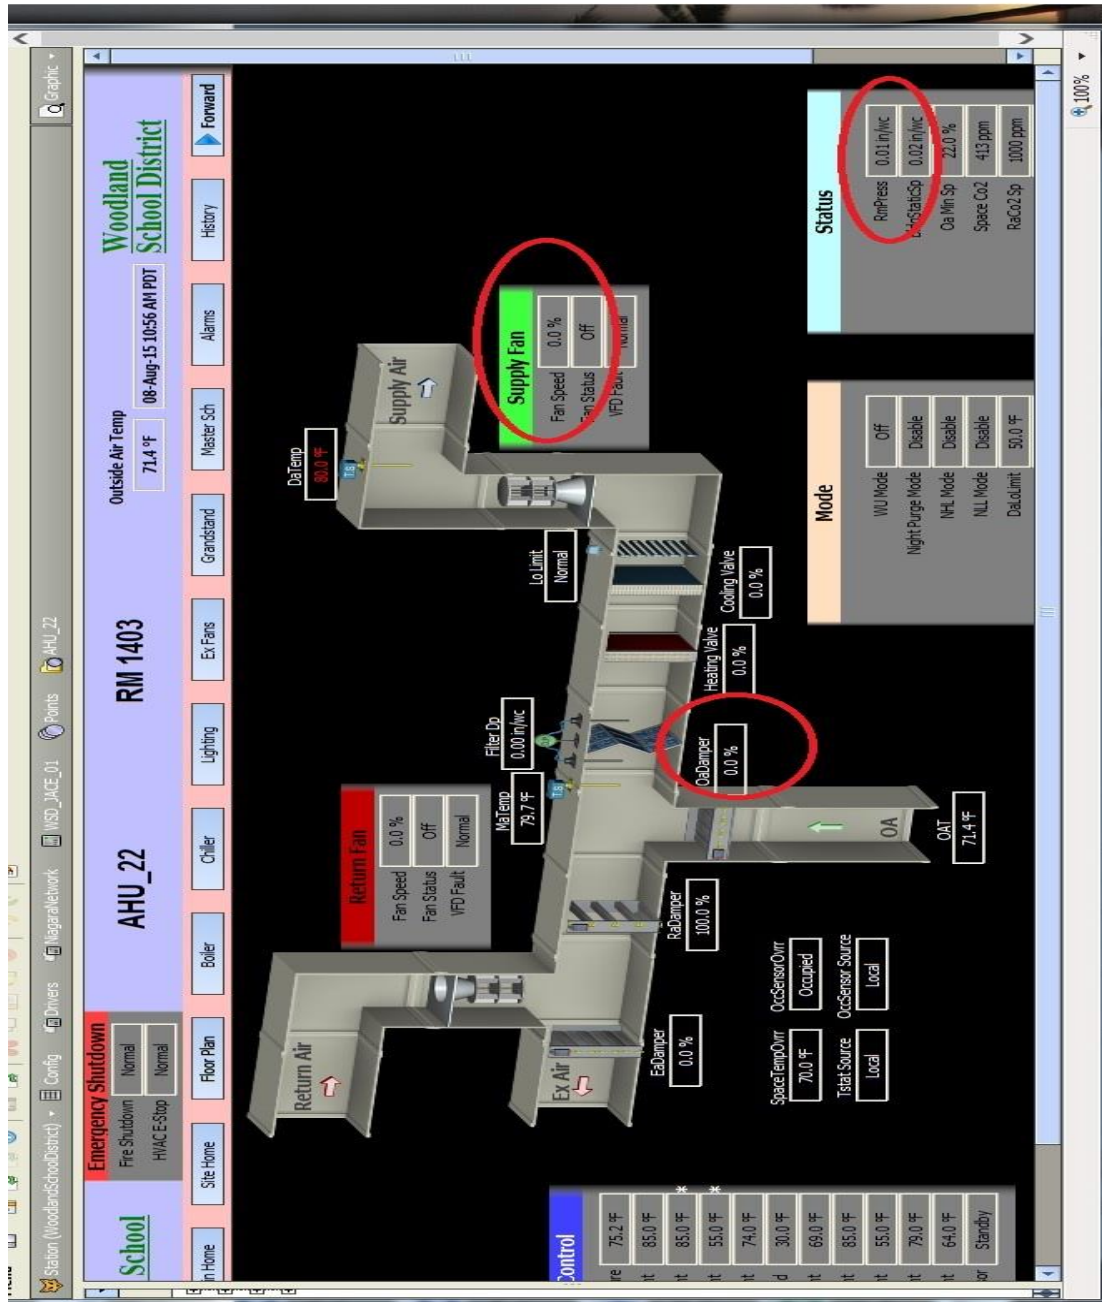
Issue M-41—AHU-22 space pressure is reading .01” with all HVAC equipment in unoccupied mode and not running.

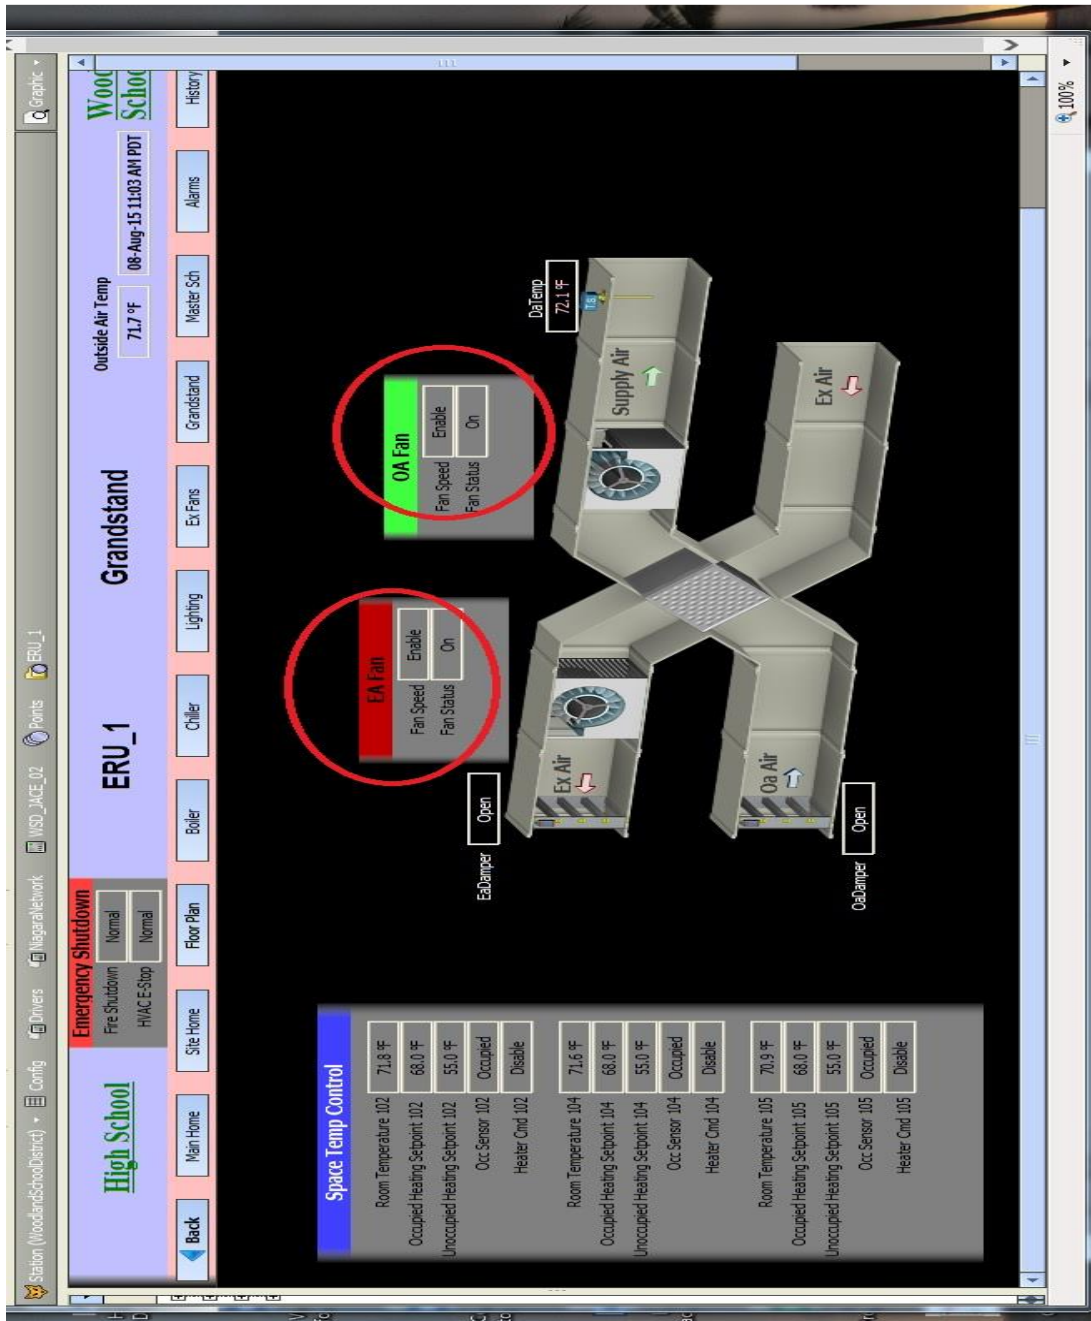
ISSUE M-42—ERU-1 serving the Stadium was running during unoccupied hrs on a Sat AM.

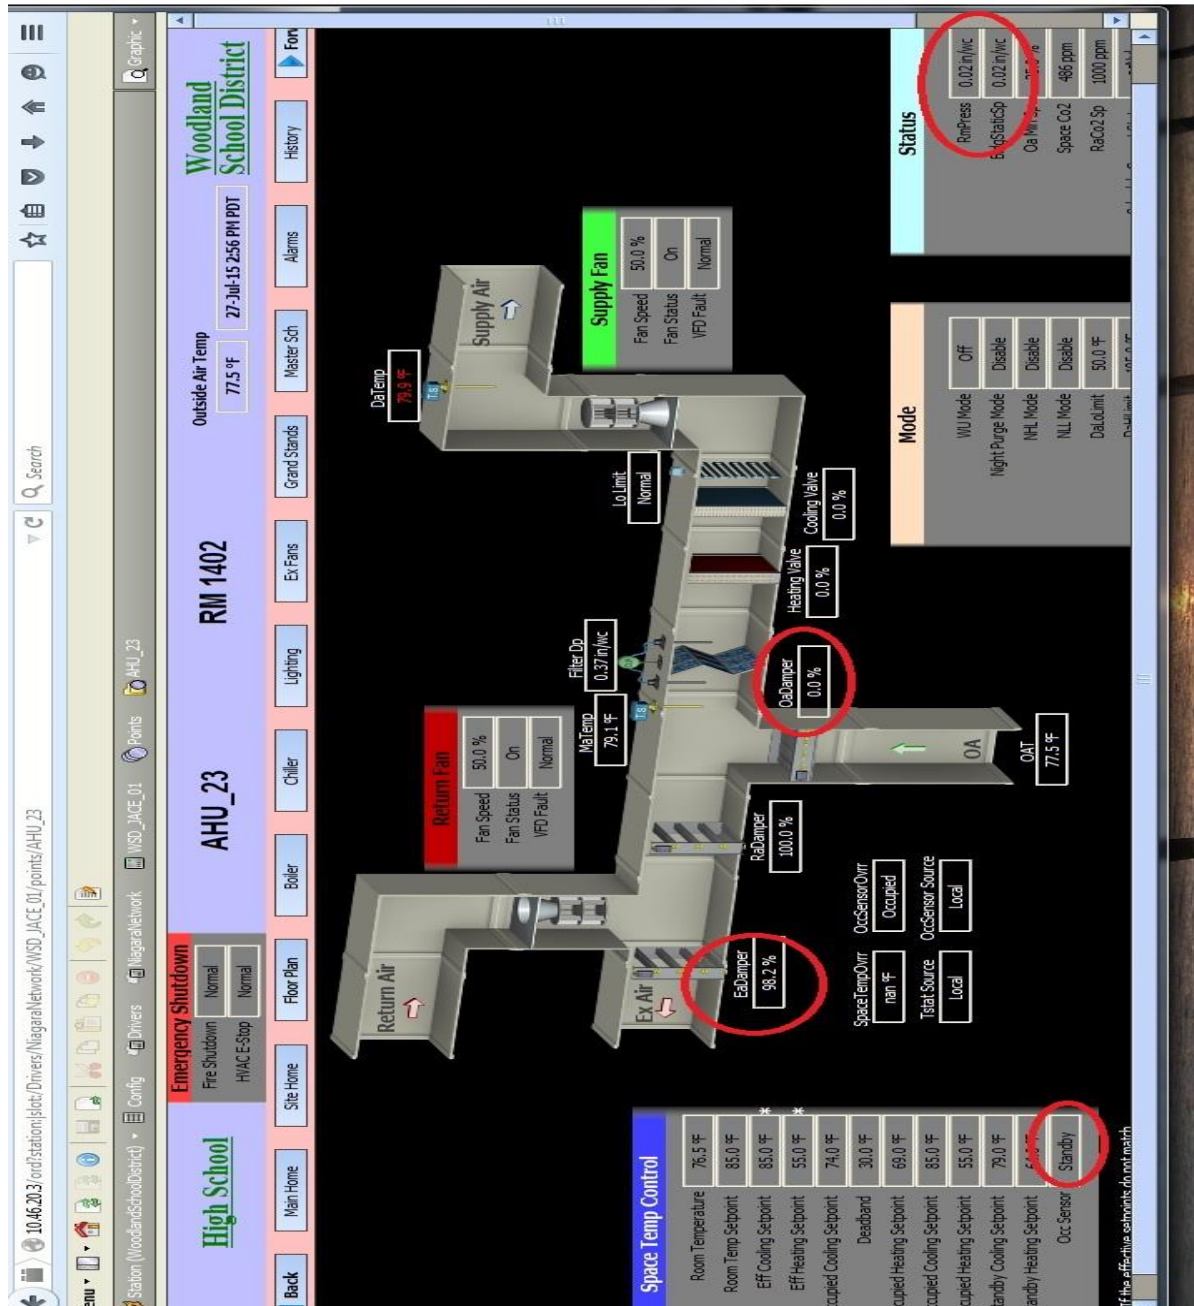
ISSUE M-47—This is a good reason to increase the space pressure set point. With the OSA damper closed, and the relief damper 100% open, the space pressure has already reached the set point.
