Final Commissioning Report For Woodland High School

July 2017

Appendix A – Field Reports, Testing & Issues Log

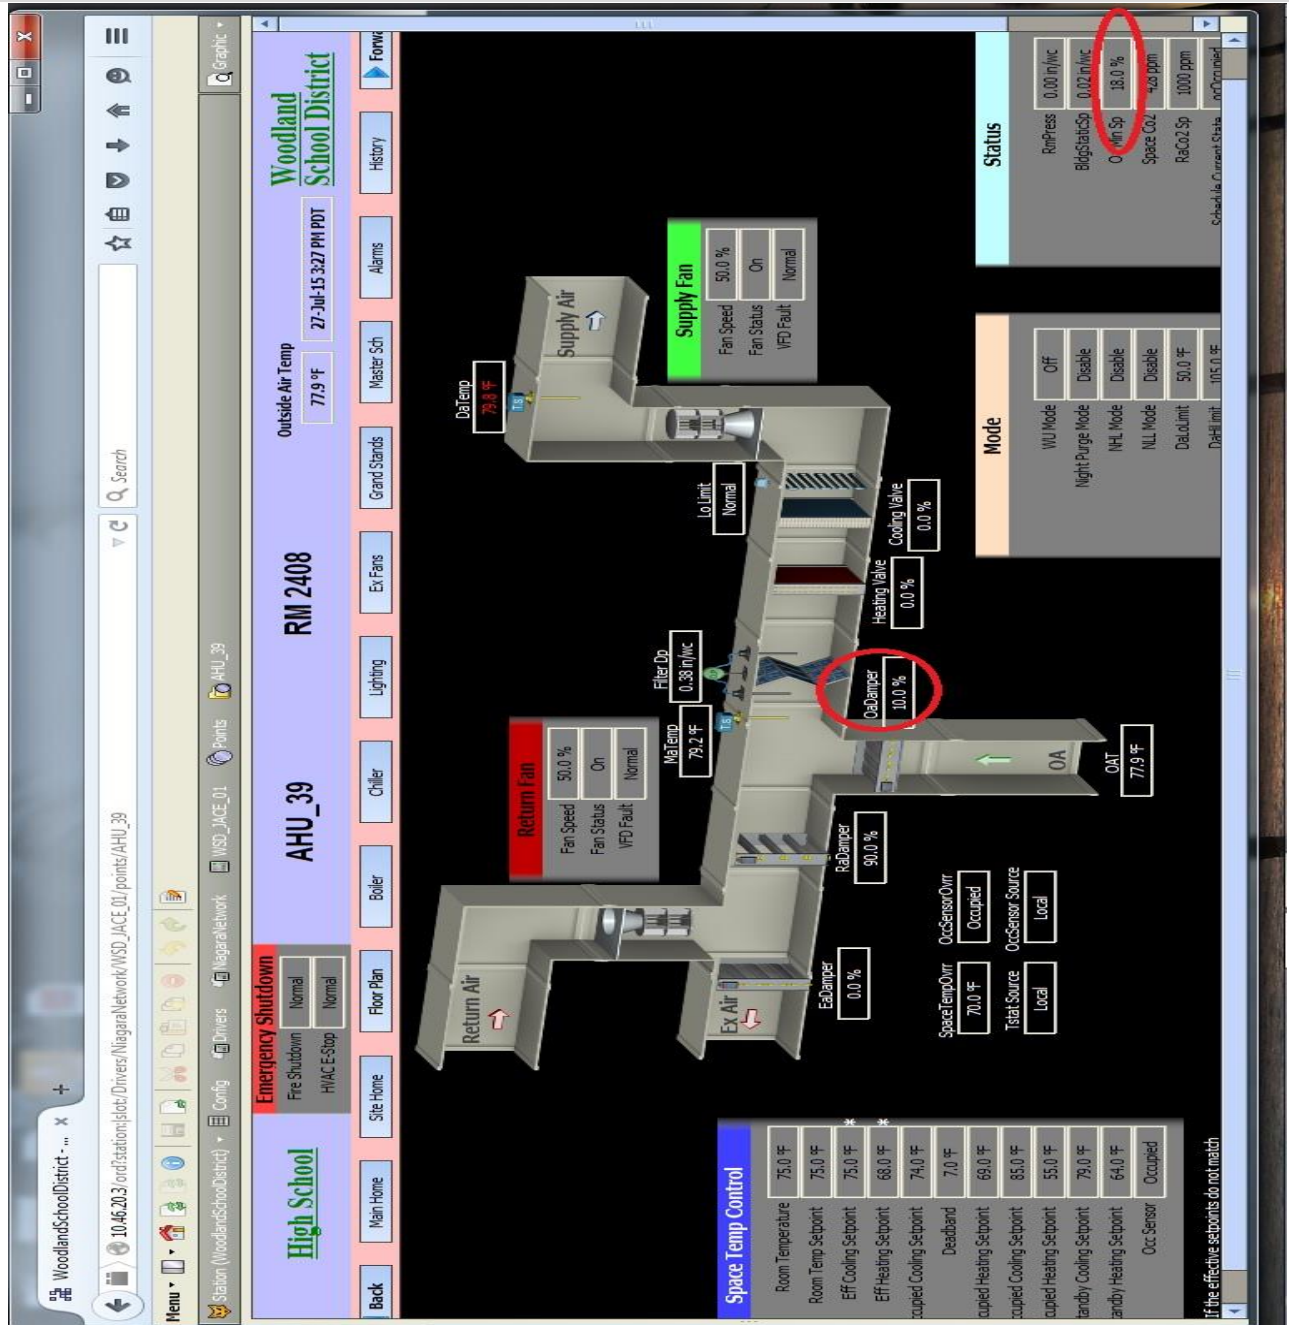
ISSUE M-48- AHU-39 OSA not moving to programmed minimum damper position.

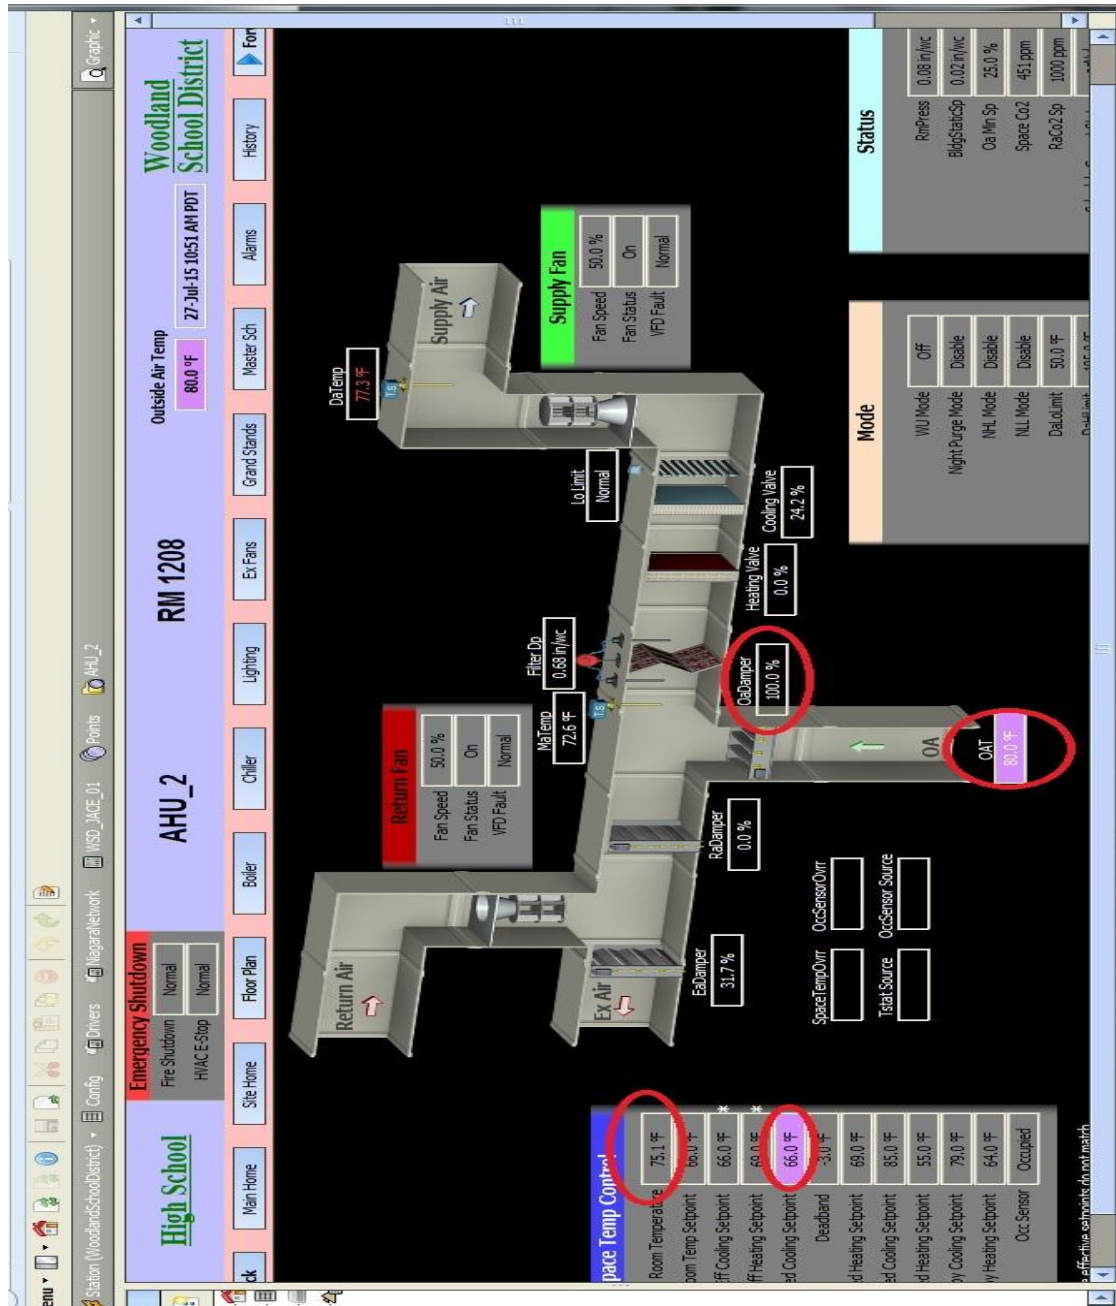
ISSUE M-49-- AHU-2's OSA damper opened during it's cooling sequence even though the OSA temperature is greater than return (space) temperatures.

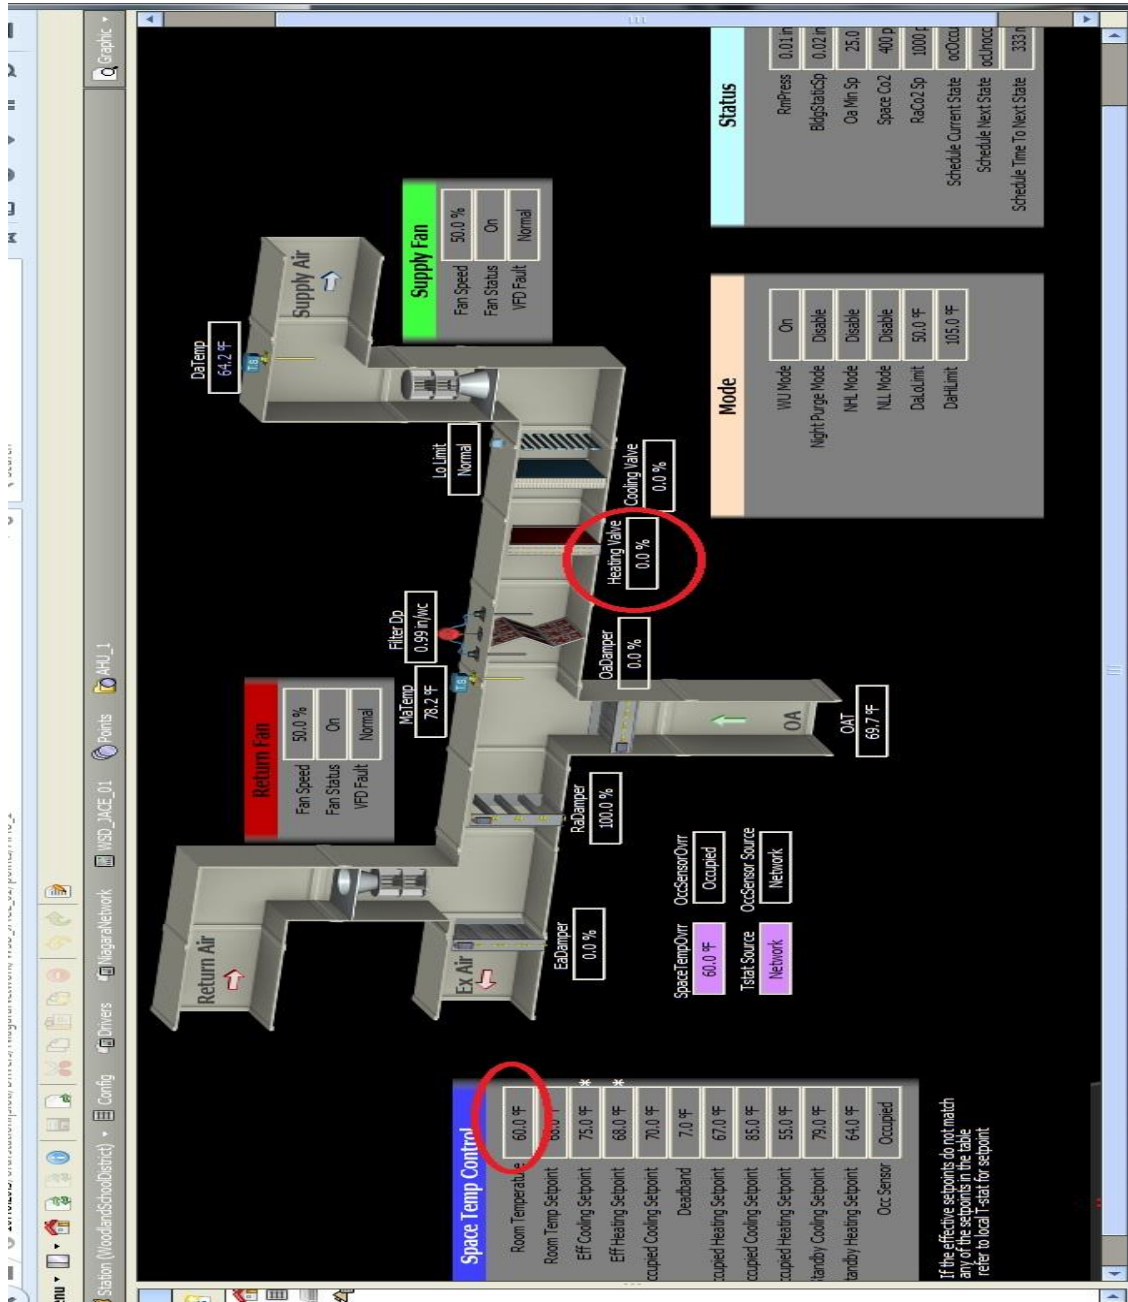
ISSUE M-51—AHU-1 did not include opening the heating valve as part of it's heating sequence of operations.

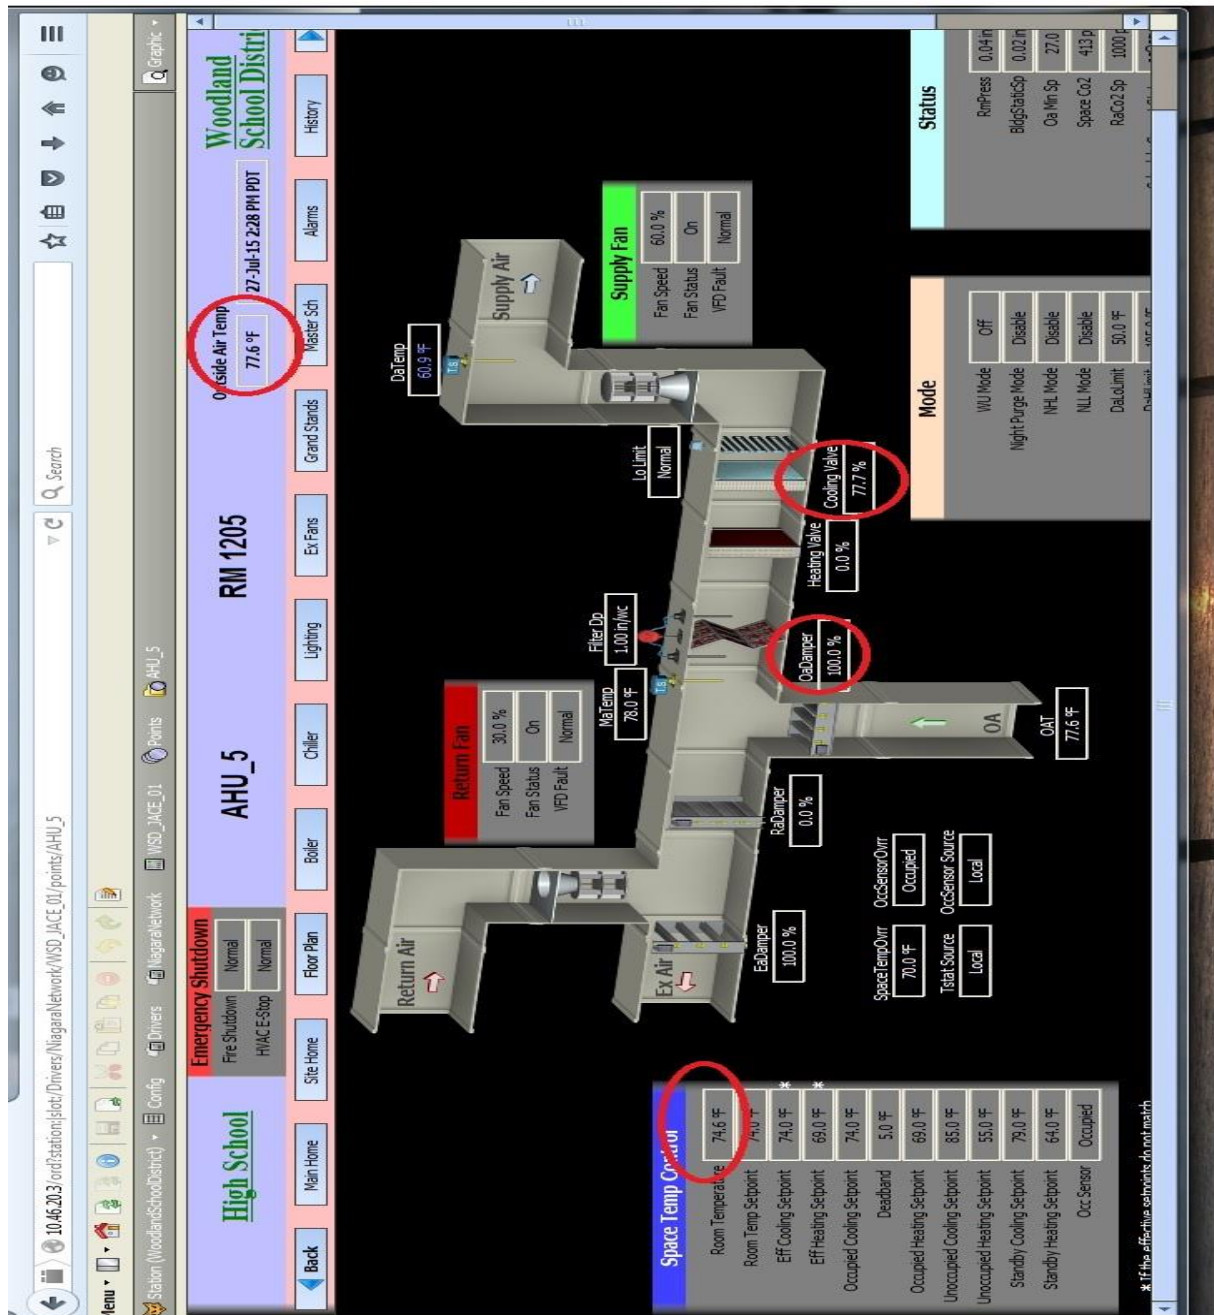
ISSUE M-52 thru M-54-- AHU-5's (AHU's 7 & 13 as well) OSA damper opened during it's cooling sequence even though the OSA temperature is greater than return (space) temperatures.

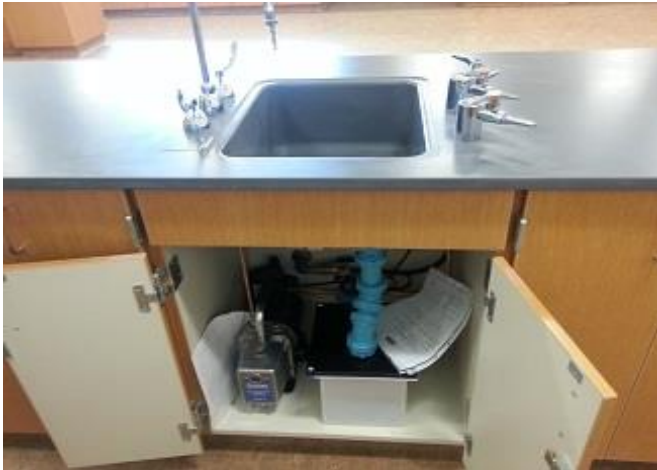
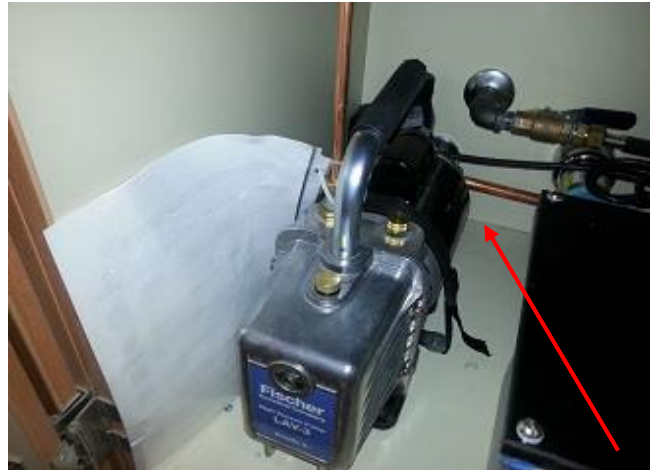
Issue ID #E-15—an end user switch has not been provided for the vacuum pump located in Chemistry lab 2401. A local switch integrated with the pump is located in the back, underside of the pump motor, but is not easily accessible.

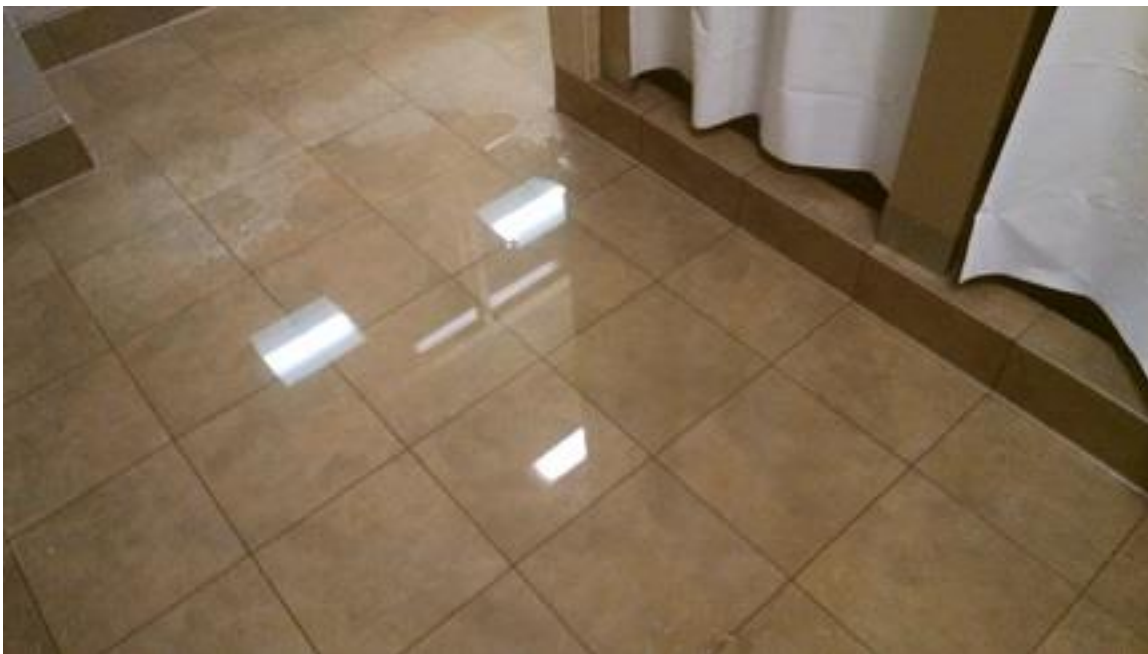
ID	Issue ID	Date Issued	Equipment ID	Issue	Assigned	Status
Plumbing Issues						
55	P-55	07.28.15	Locker Showers	Water is not being kept within the stall and is pooling on the floor of the toilet creating a slipping hazard. The floor is not sloped from this area towards the drain.	Skanska	Closed
56	P-56	07.28.15	Gym Concessions stand sink	The sink nearest the roll up door has very little hot or cold water flow.	Eagle Harbor	Closed
57	P-57	07.28.15	Kitchen Scullery sink	The sink located next to the dishwasher drips when shut off.	Eagle Harbor	Closed
58	P-58	07.28.15	Kitchen spray hose temps	The hot water does not reach an appropriate temperature. 70°F is noted on temperature gauge in wall box even though mixing valve is set to full hot.	Eagle Harbor	Closed
59	P-59	07.28.15	Rm 1409 faucet	Do the sinks require a vacuum break because of the hose bib installed on the fixture in place of an aerator?	Eagle Harbor	Closed

Issue ID #P-55—water spills and pools up outside showers. Slipping hazard

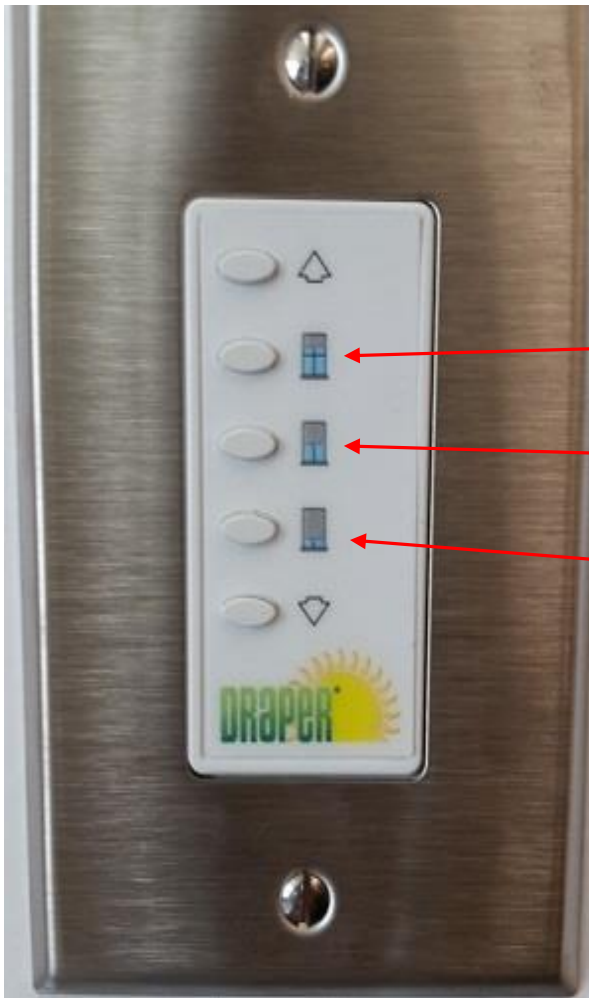
This is the 25% position button.

This is the 50% position button.

This is the 75% position button.

Issue ID #G-64—the 5 position control panel has not been programmed correctly and according to the diagrams on the switch itself. The arrow up and down buttons should send the shades 100% open and closed. The other buttons should index the shades to the 25-50-75% positions. Skanska originally stated the three center buttons were not to be programmed, however, CSG discovered they have all been programmed to move the shades fully closed. CSG believes if they are to be programmed, they should be done so to not only match the configuration of the diagrams on the control panel but also matches typical industry standards.

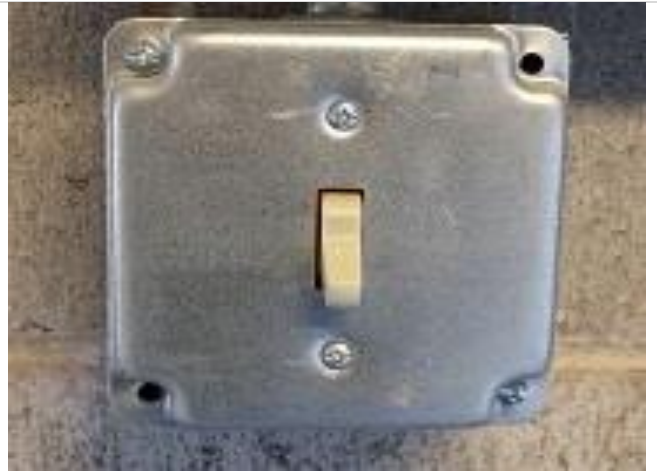
Issue ID E-76—Main stadium light switch?

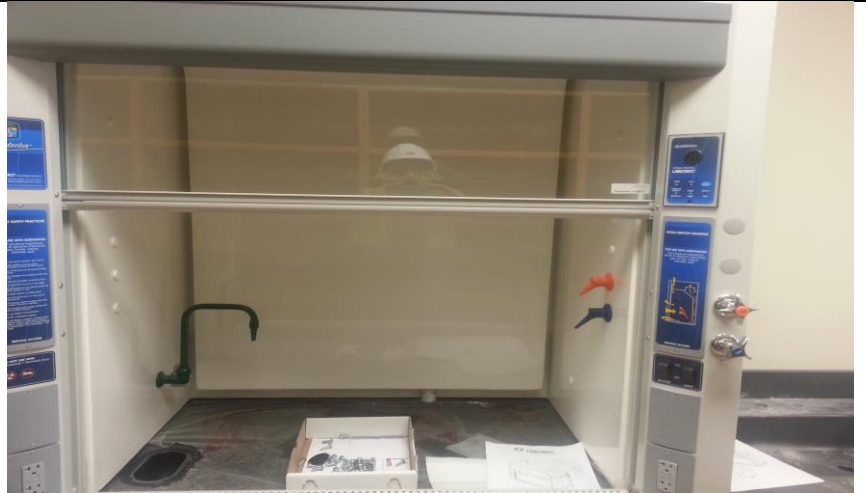
The laboratory hoods have been installed. A question has been raised regarding the calibration of the Guardian airflow monitors.

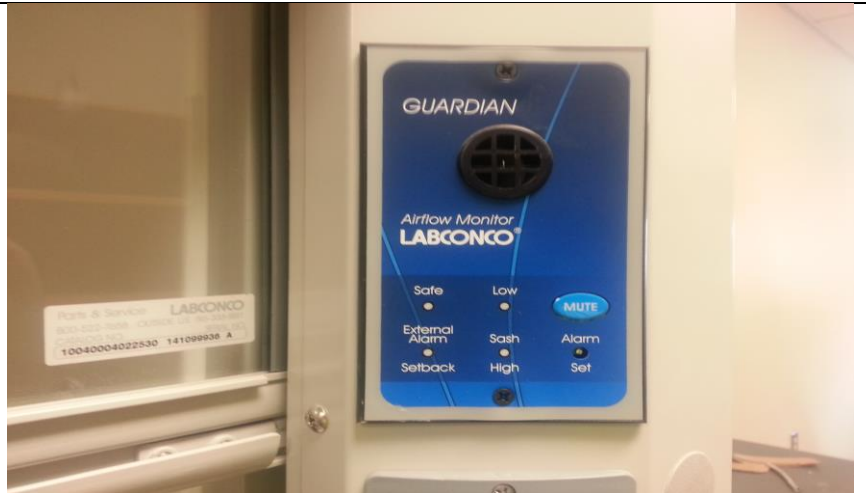
The project specifications do not identify who will ensure these airflow meters are calibrated to alarm an end user the velocity across the open sash is adequate to provide the necessary protection to the end user. Because face velocities must be measured, either the TAB contractor or manufacturer seems to be the appropriate party.

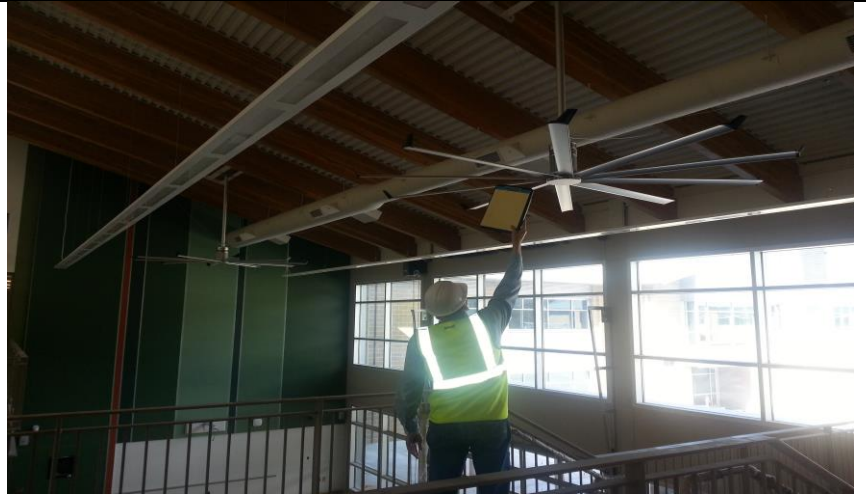
Here one can see the proximity of the paddle fans to the deck height at the top of the stairs. Does the school district have concerns with the ability to reach the blades while it is operating? Is the PF's effectiveness of limiting stratification inhibited by the stairs? Does the installation meet the required minimum clearance of 10' above floor?

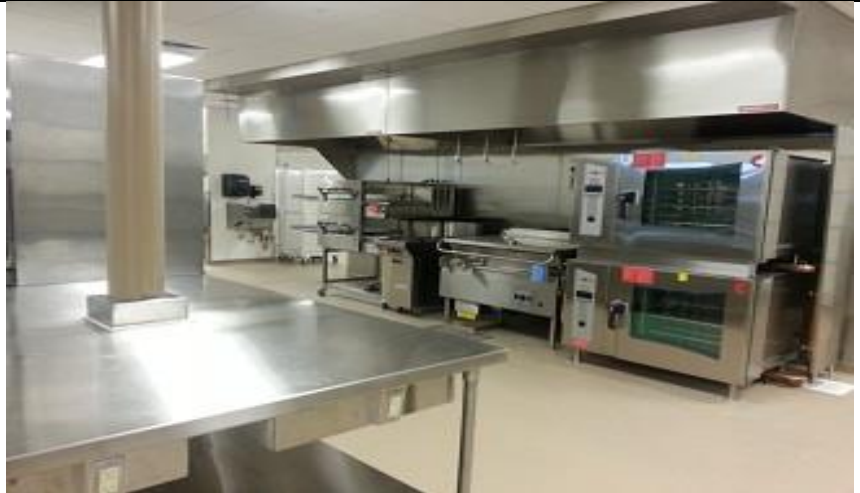
The Kitchen is mostly complete with all equipment installed. The freezer was noted as having condensation build-up all around the door.

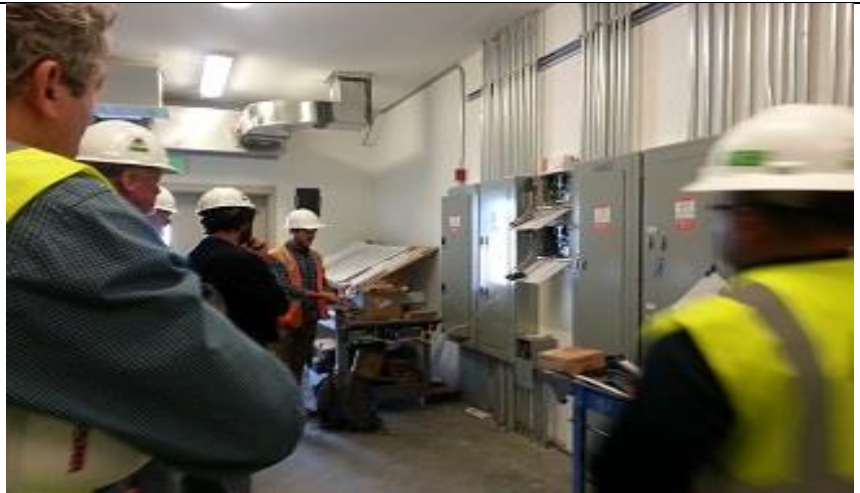
Low voltage lighting controls system training occurred on this day. CSG witnessed and helped the Woodland school district maintenance staff identify areas that were not yet ready for programming or training so that it could be later identified on a return trip by the manufacturer's representative.
